### **Baja SAE Technical Inspection Bulletin**

2015-1

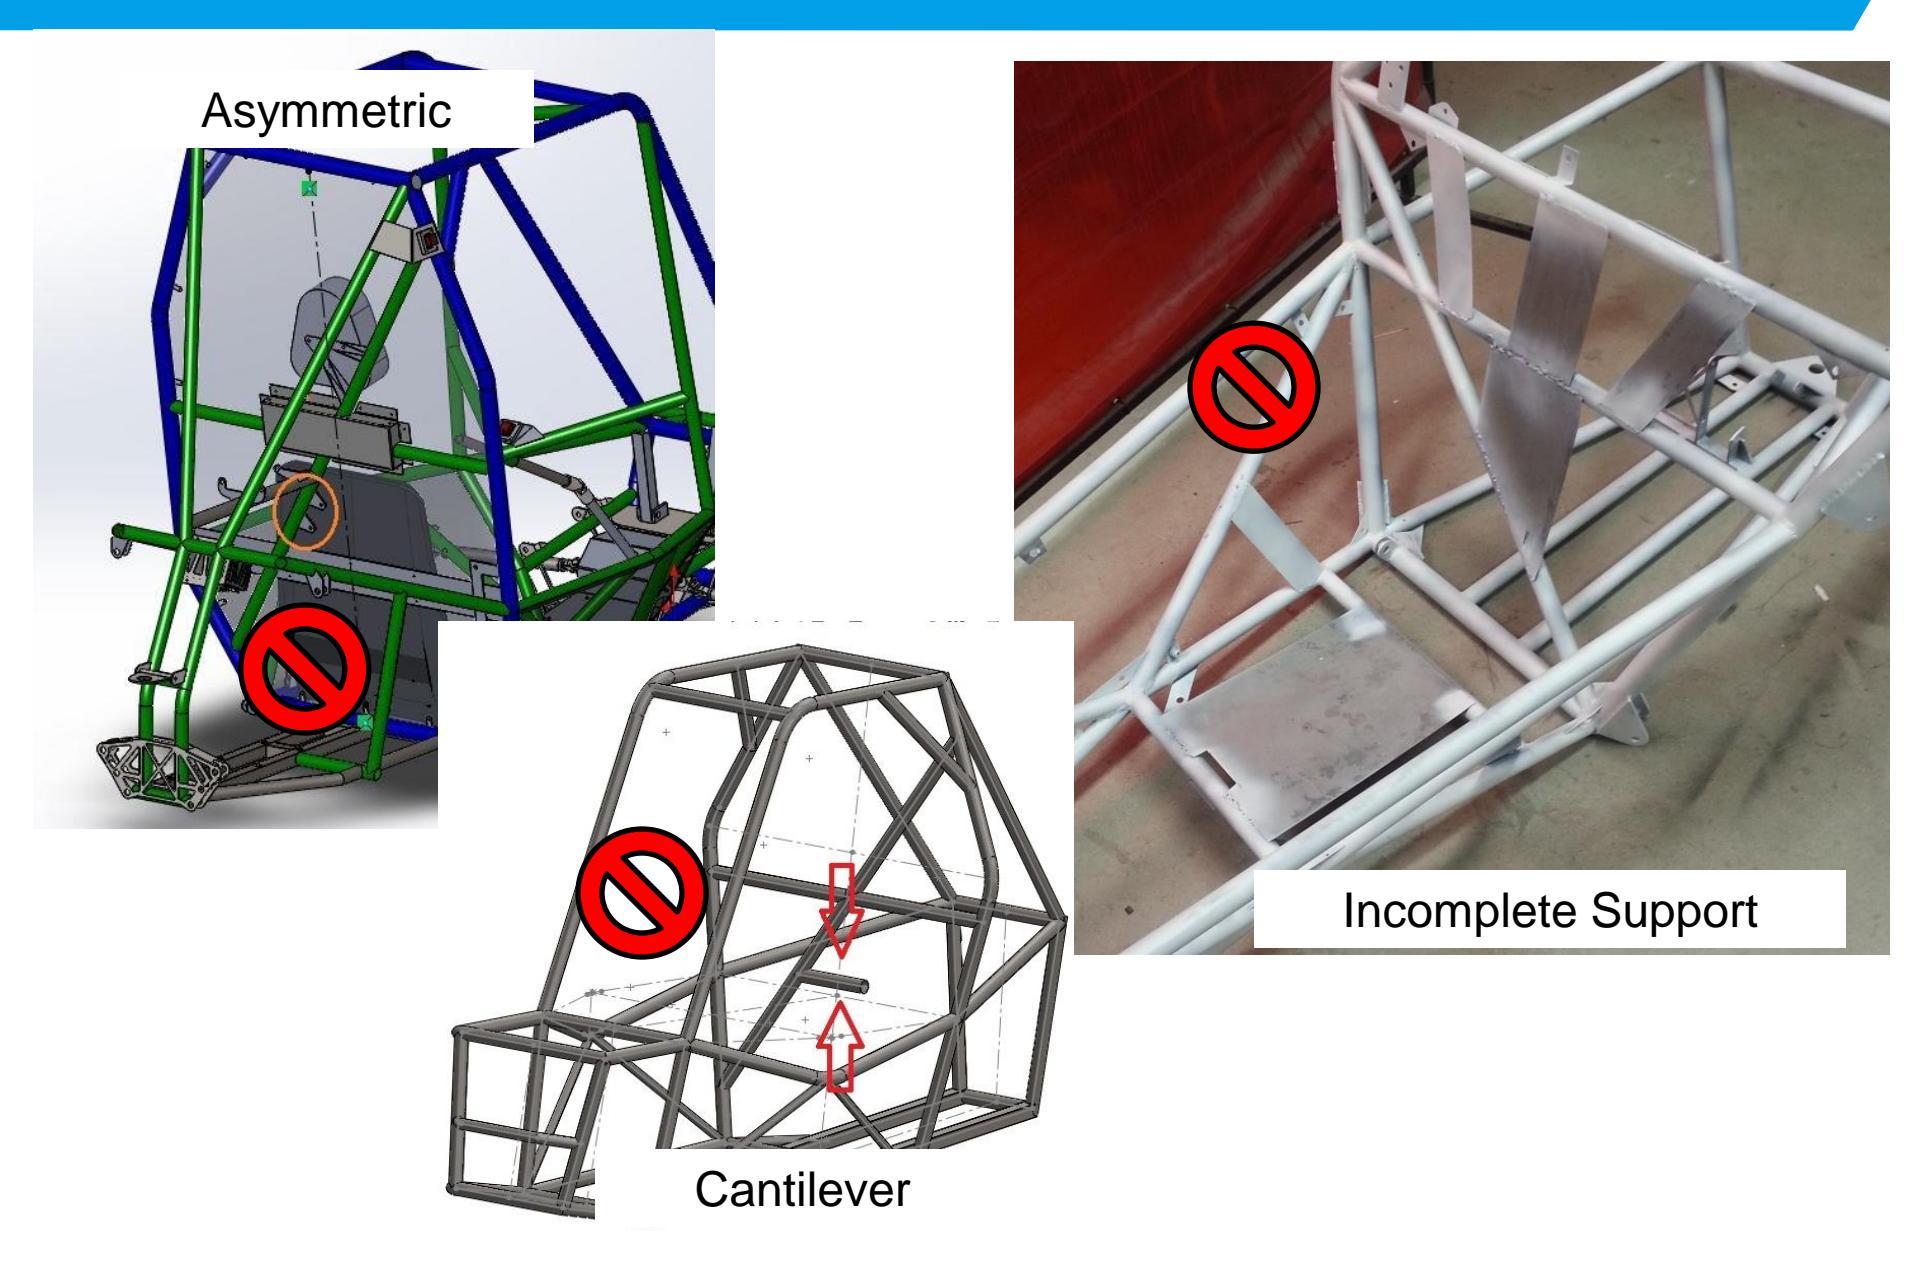
- B10.7.3 "...mounting points shall be generally symmetrical about the centerline of the seat itself or the vehicle."
  - Just as the seat belt mounts are symmetrical, the seat mounting should be symmetrical to evenly distribute loads.
  - Similarly, as cantilevered seatbelt mounts are not allowed, cantilevered seat mounts will not be accepted. This arrangement puts an undue moment on thin-walled frame tubes and does not evenly distribute the load of the driver to the frame.

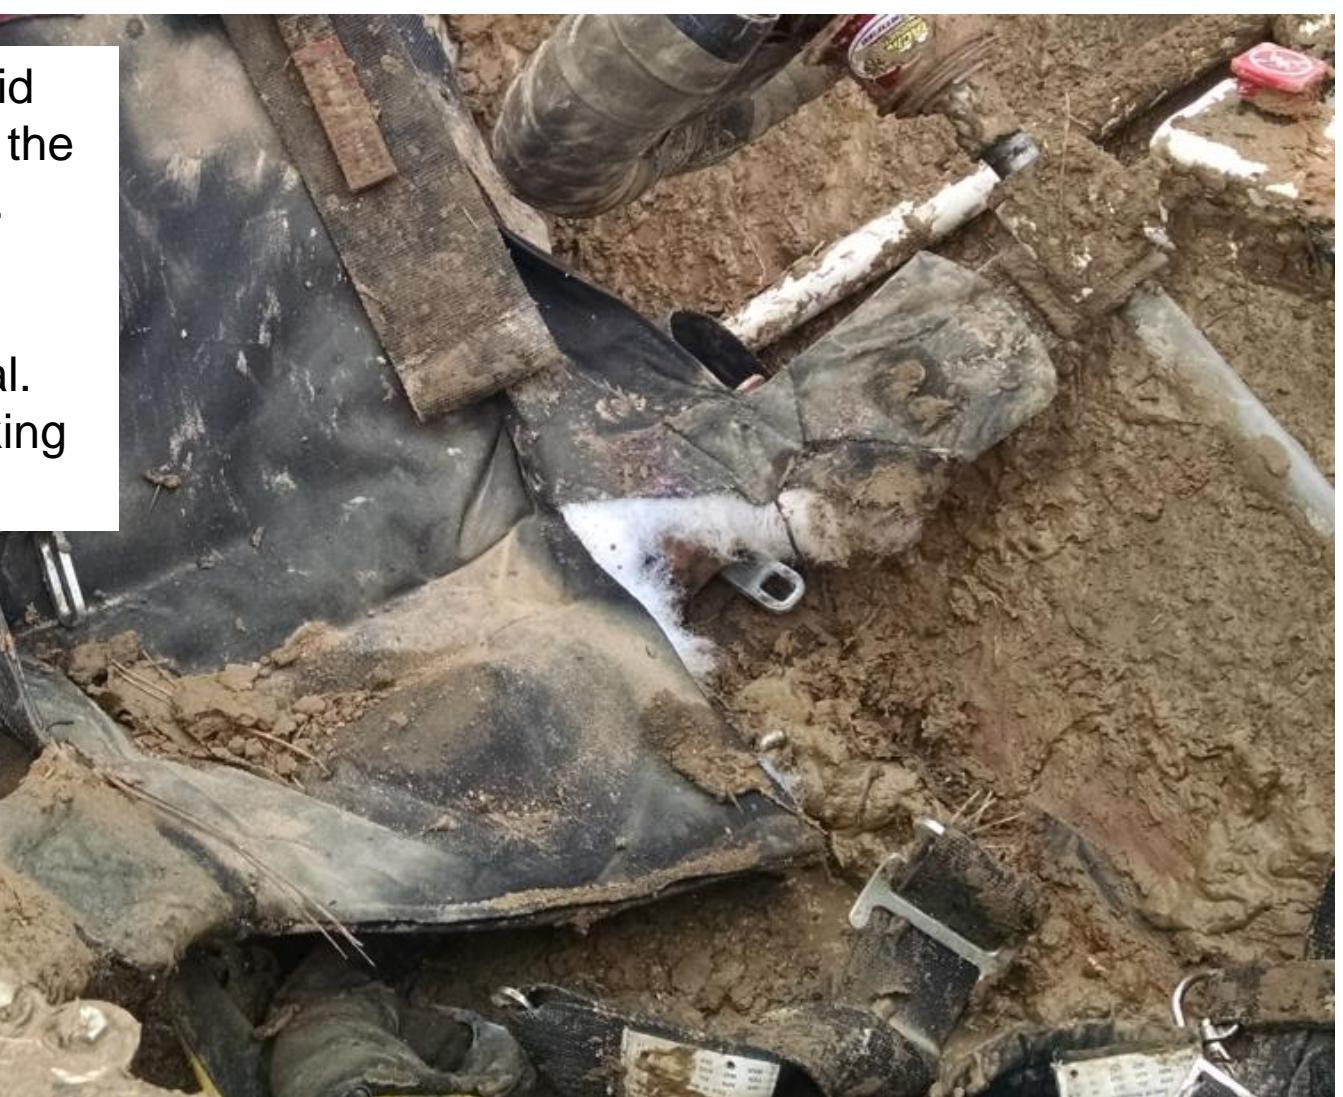
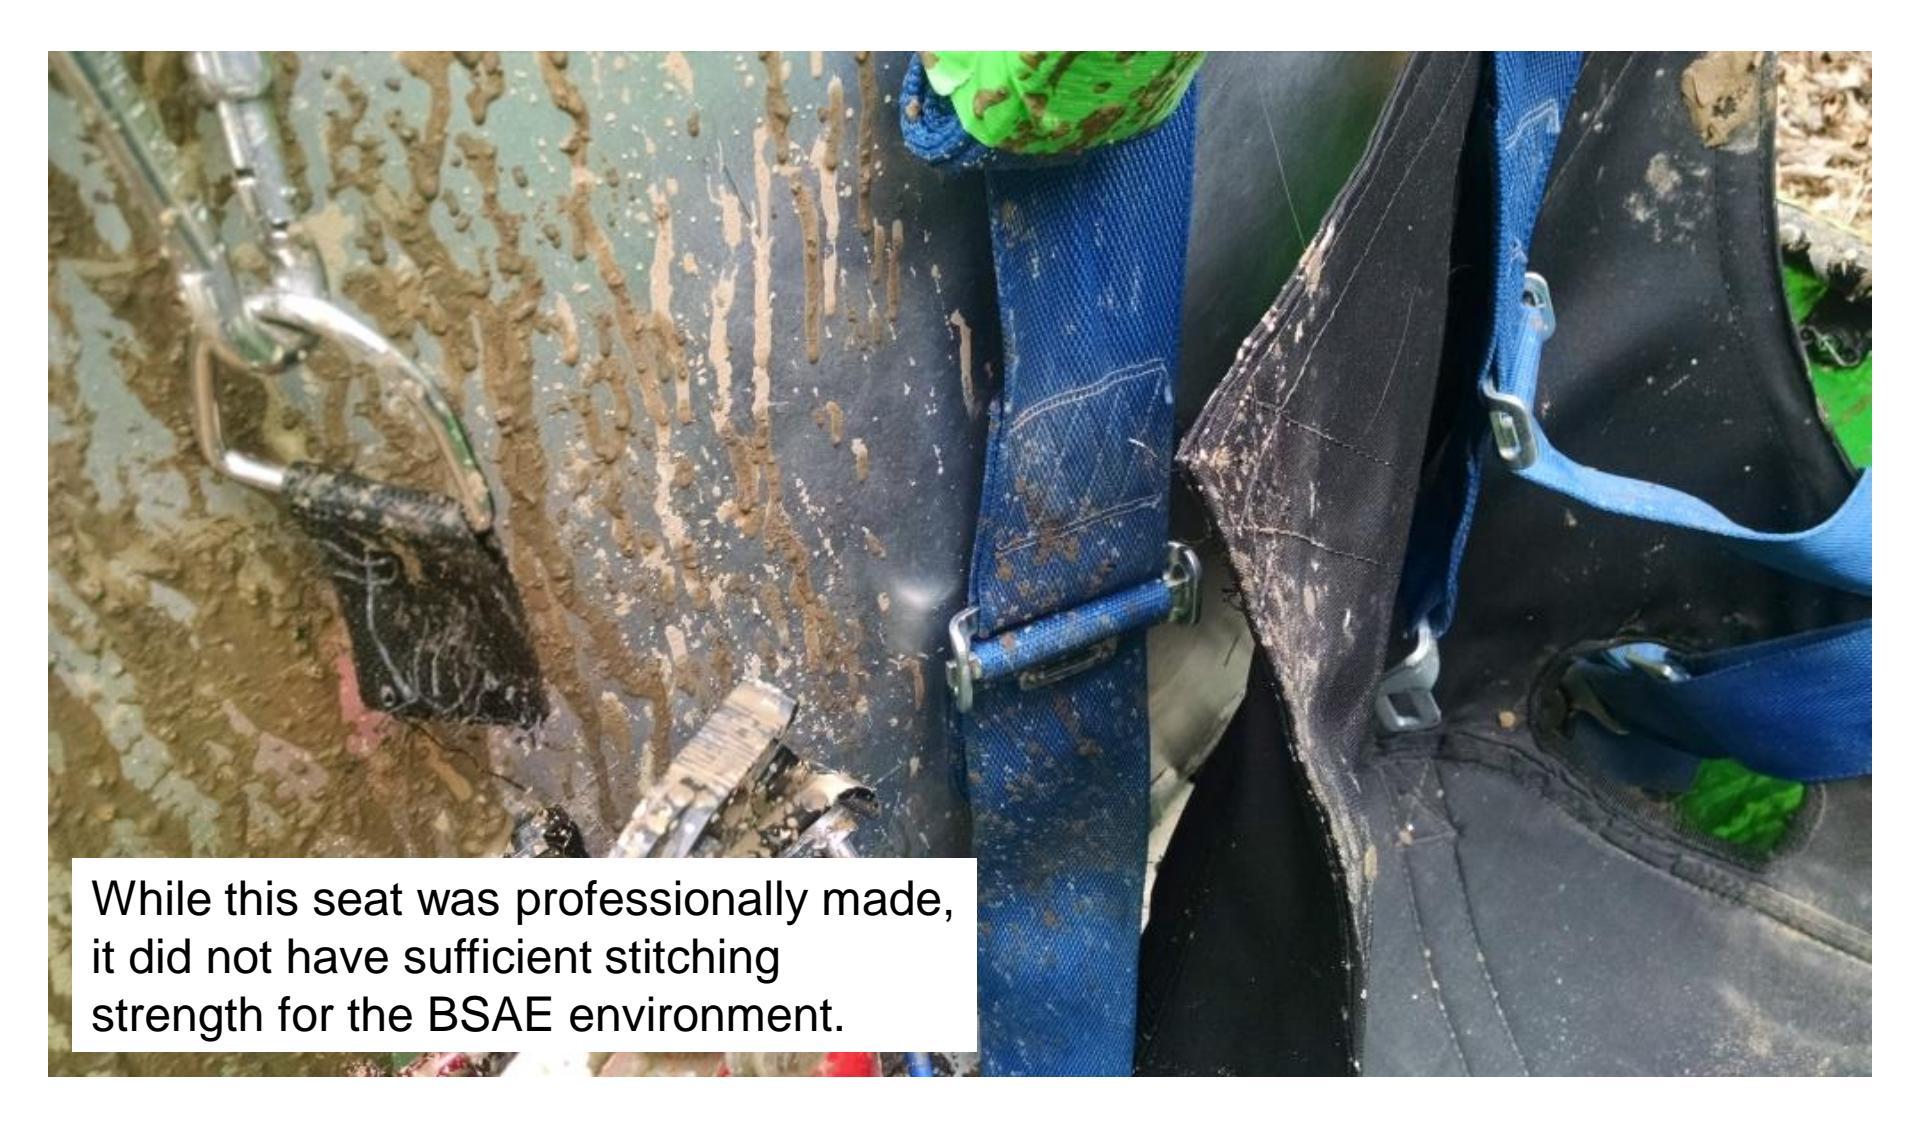
- B10.7.1 "Suspension seats shall be constructed of durable, woven materials. Stitching shall be neat and sufficient to effectively join all seat parts and safely direct forces from the driver to the vehicle frame."
- Two suspension seats failed during BSAE Auburn 2015.
  - One failure was due to overloaded material (seat made in-house).
  - The second was due to insufficient stitching on webbing (seat professionally made).

The seat webbing did not continue across the car under the driver. Short webbing runs terminated at the canvas seat material. The canvas was taking all vertical load.

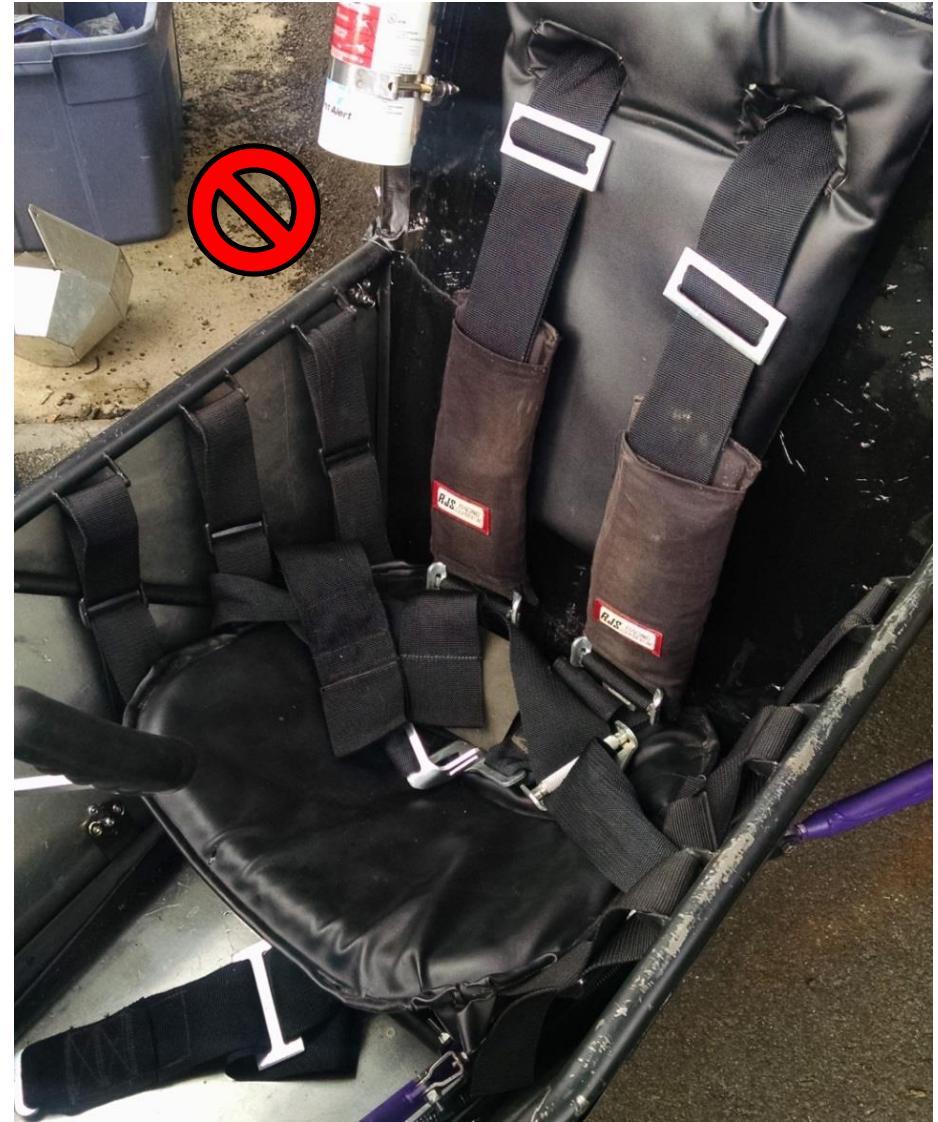
- The seat pictured was a combination of suspension seat (seat bottom plane) and conventional seat (seat back plane)
- This seat did not satisfy requirements for either seat design.
- The seat bottom mounts were not within 2 inches of a frame node (as measured by the center of the webbing.
- The seat back did not have sufficient rigidity to keep the driver properly positioned with respect to the seat belts and from bulging the firewall rearward.
- There have been certain cases in previous years where seat failures allowed the driver to partially pass through the plane of the RRH and come in contact with engine exhaust or drivetrain components.

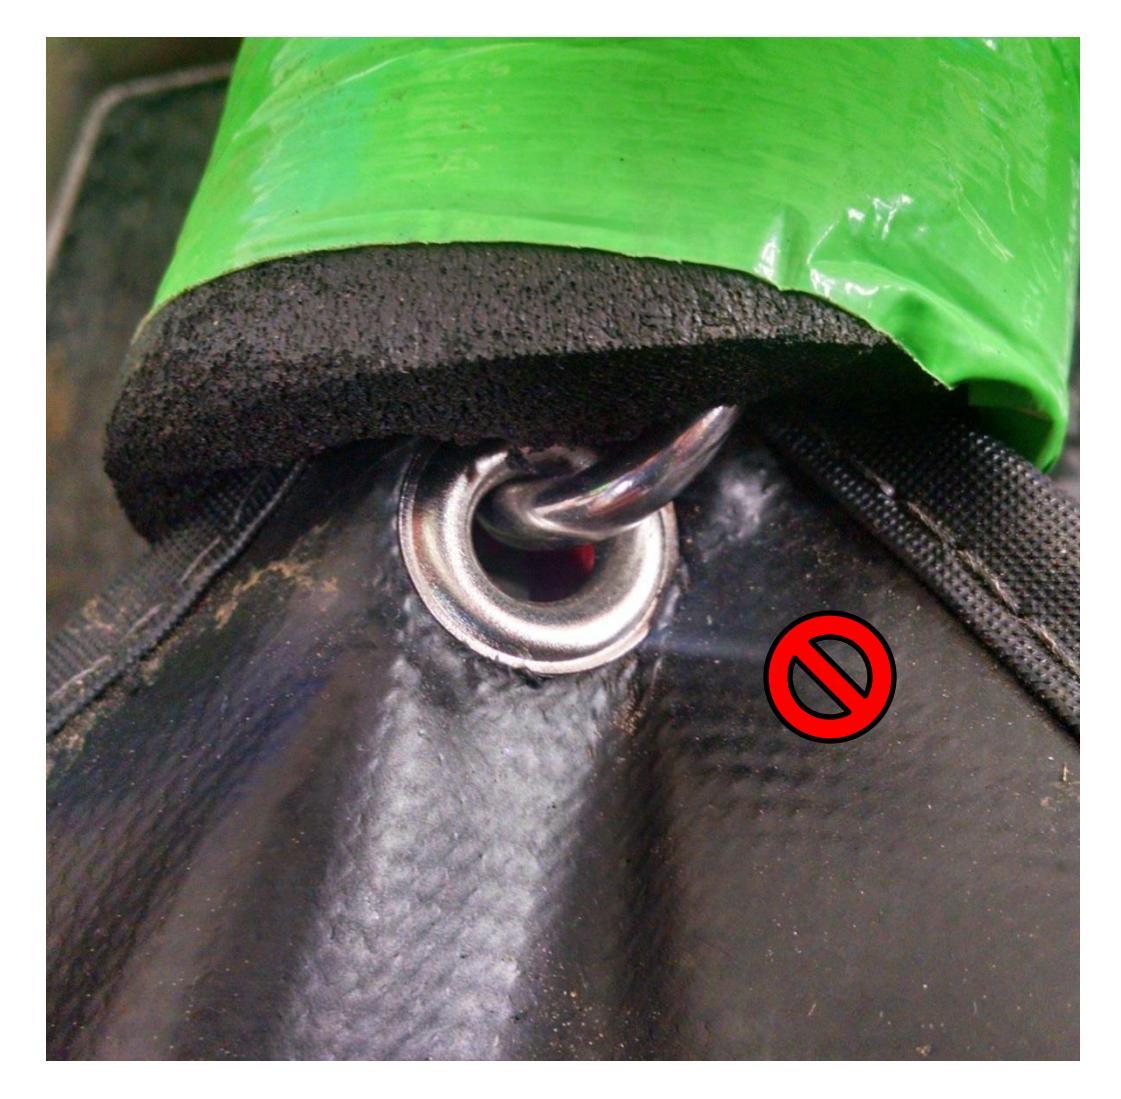
- This grommet was already tearing out before the team arrived at tech inspection.
- Components that are damaged and failed will not be accepted at tech inspection.

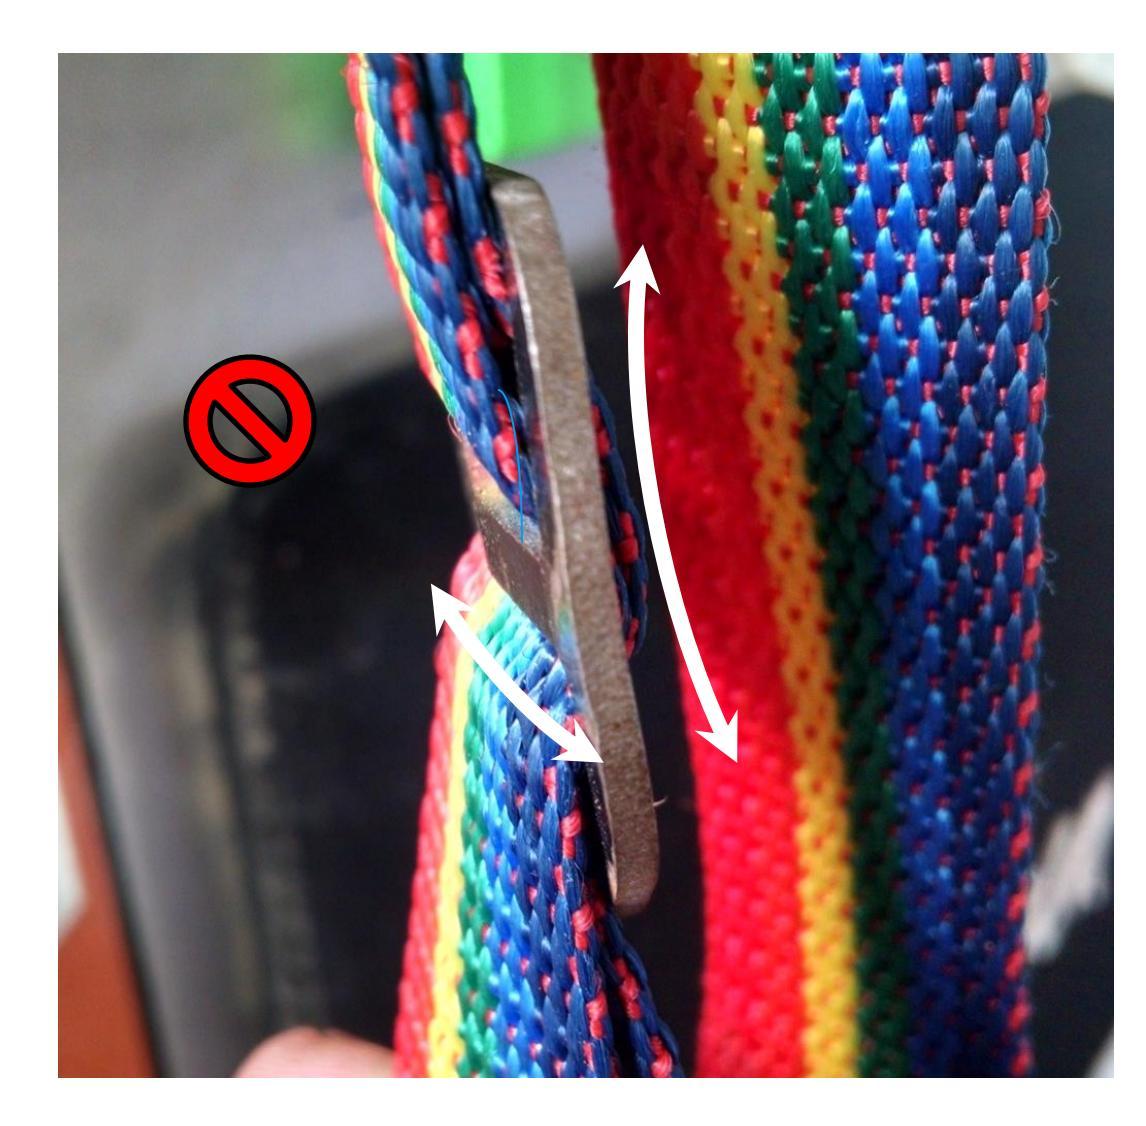
- The same team as the previous slide also showed up with buckles that were yielded.
- The team was required to change hardware.

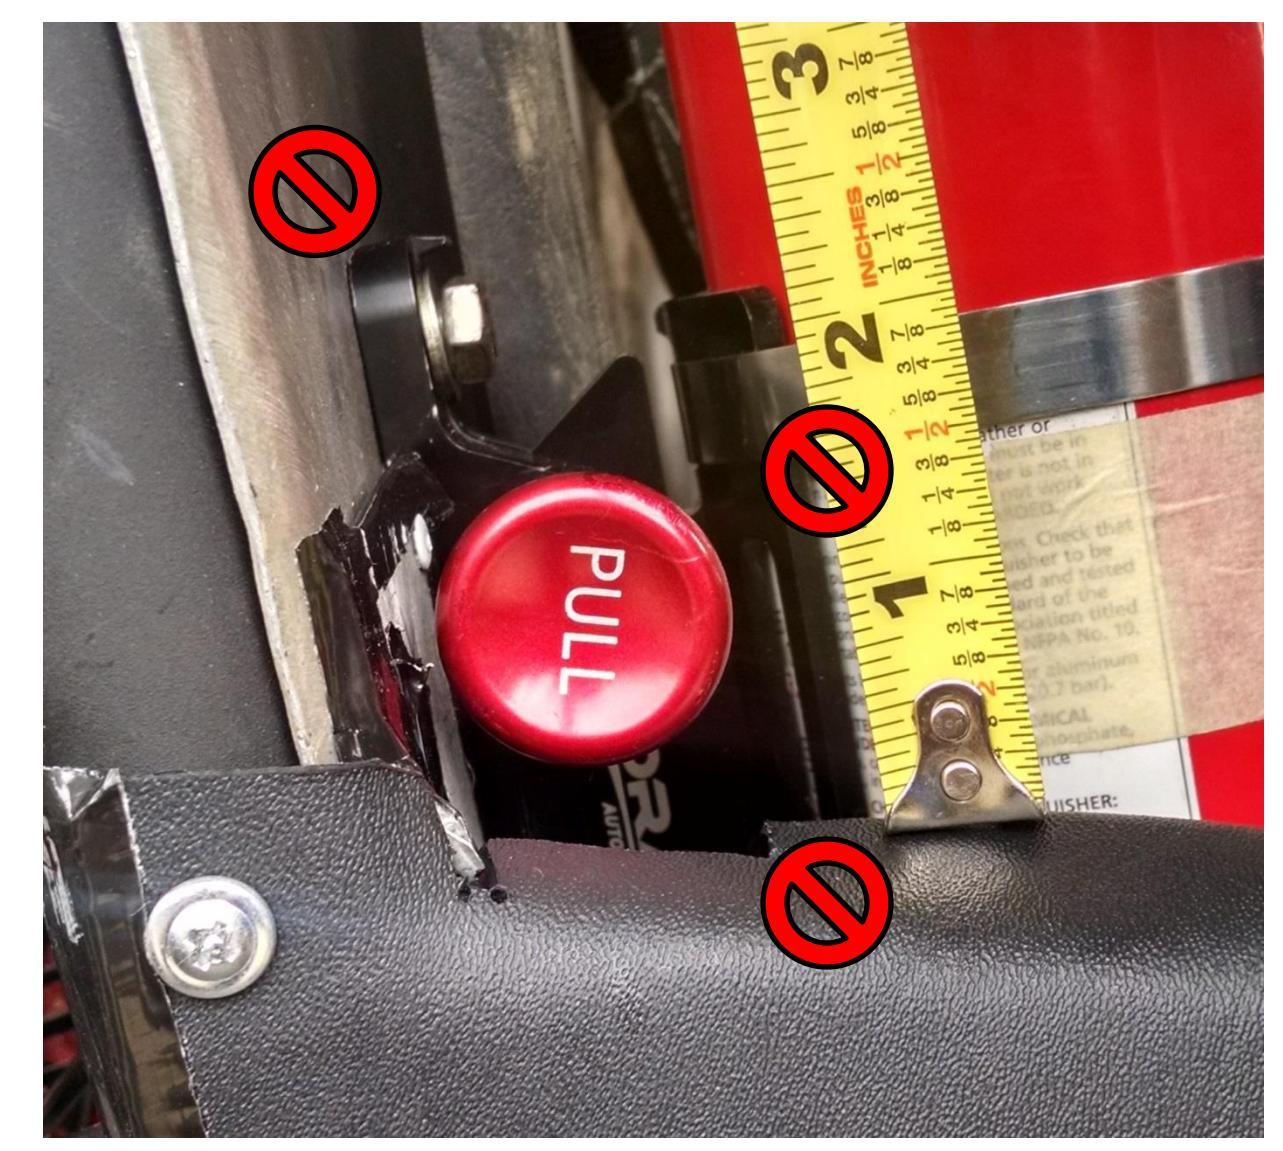
- Improper hardware for mount design.
- Sharp edges near pull knob.
- Insufficient clearance around pullknob.

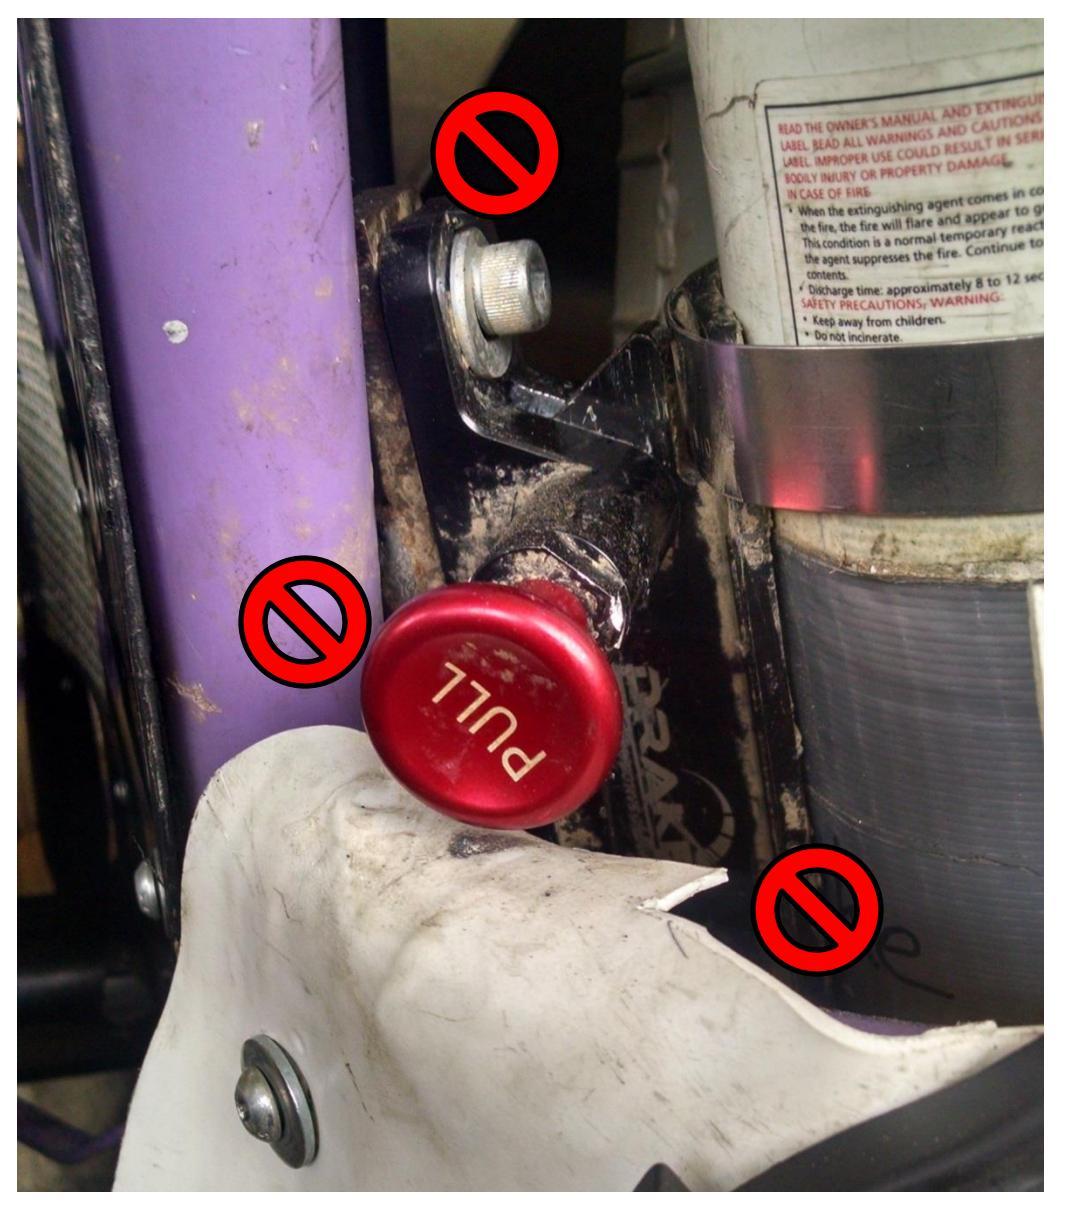
- Improper hardware for mount design.
- Sharp edges near pull knob.
- Insufficient clearance around pull-knob.

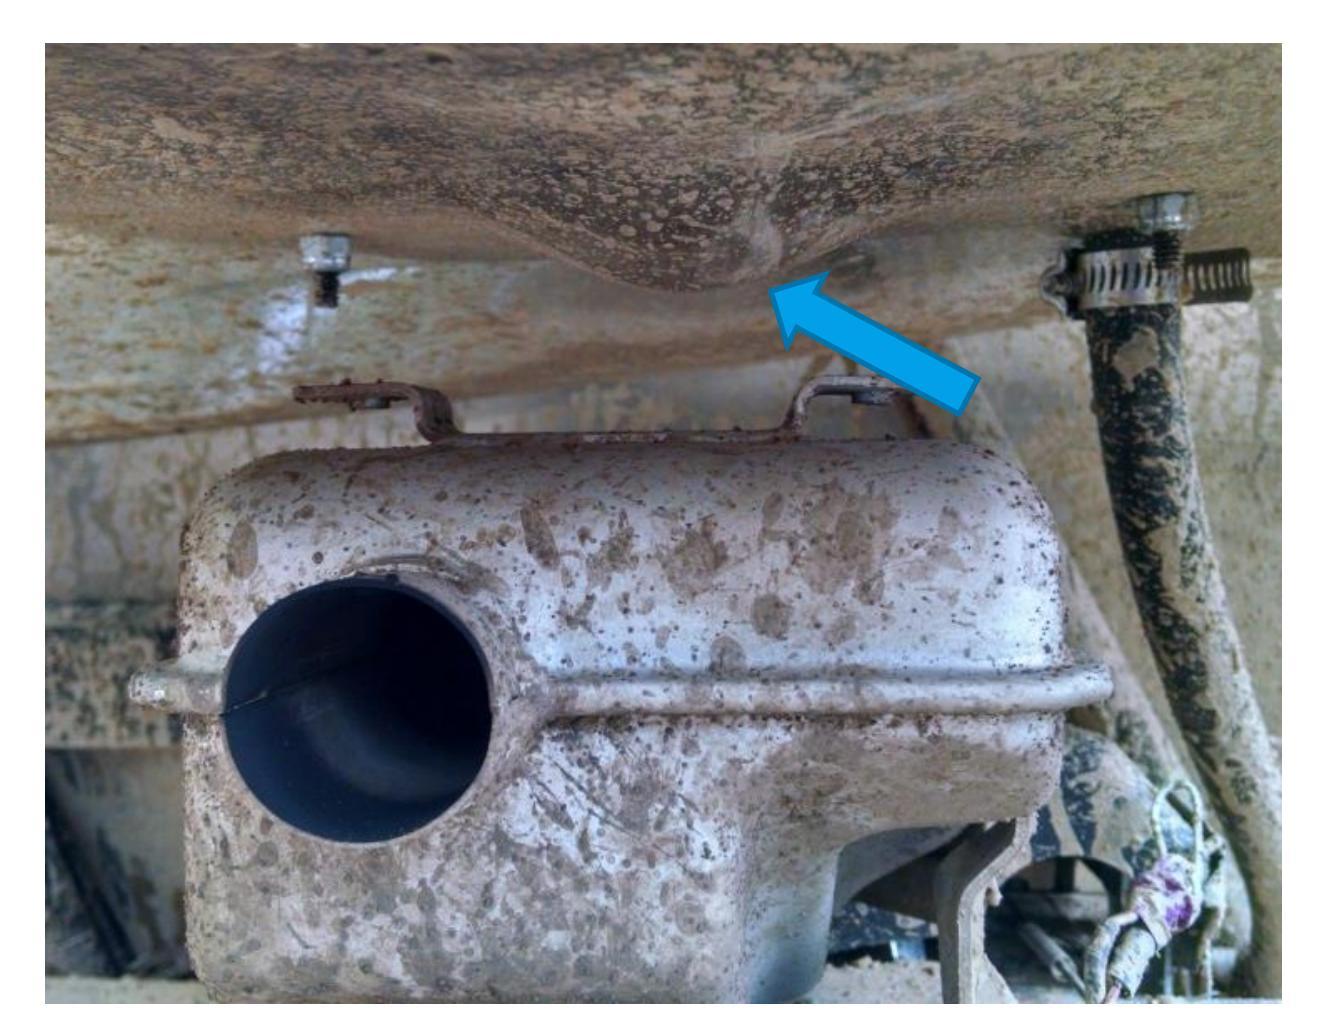
- This plastic splash shield was mounted too close to the muffler and began to sag. If you elect to use plastic splash shields, they must be mounted away from hot exhaust or be made from sheet metal.
- A few teams did not meet the fuel tank mounting tab length requirement. These tabs shall not be longer than 2 inches.

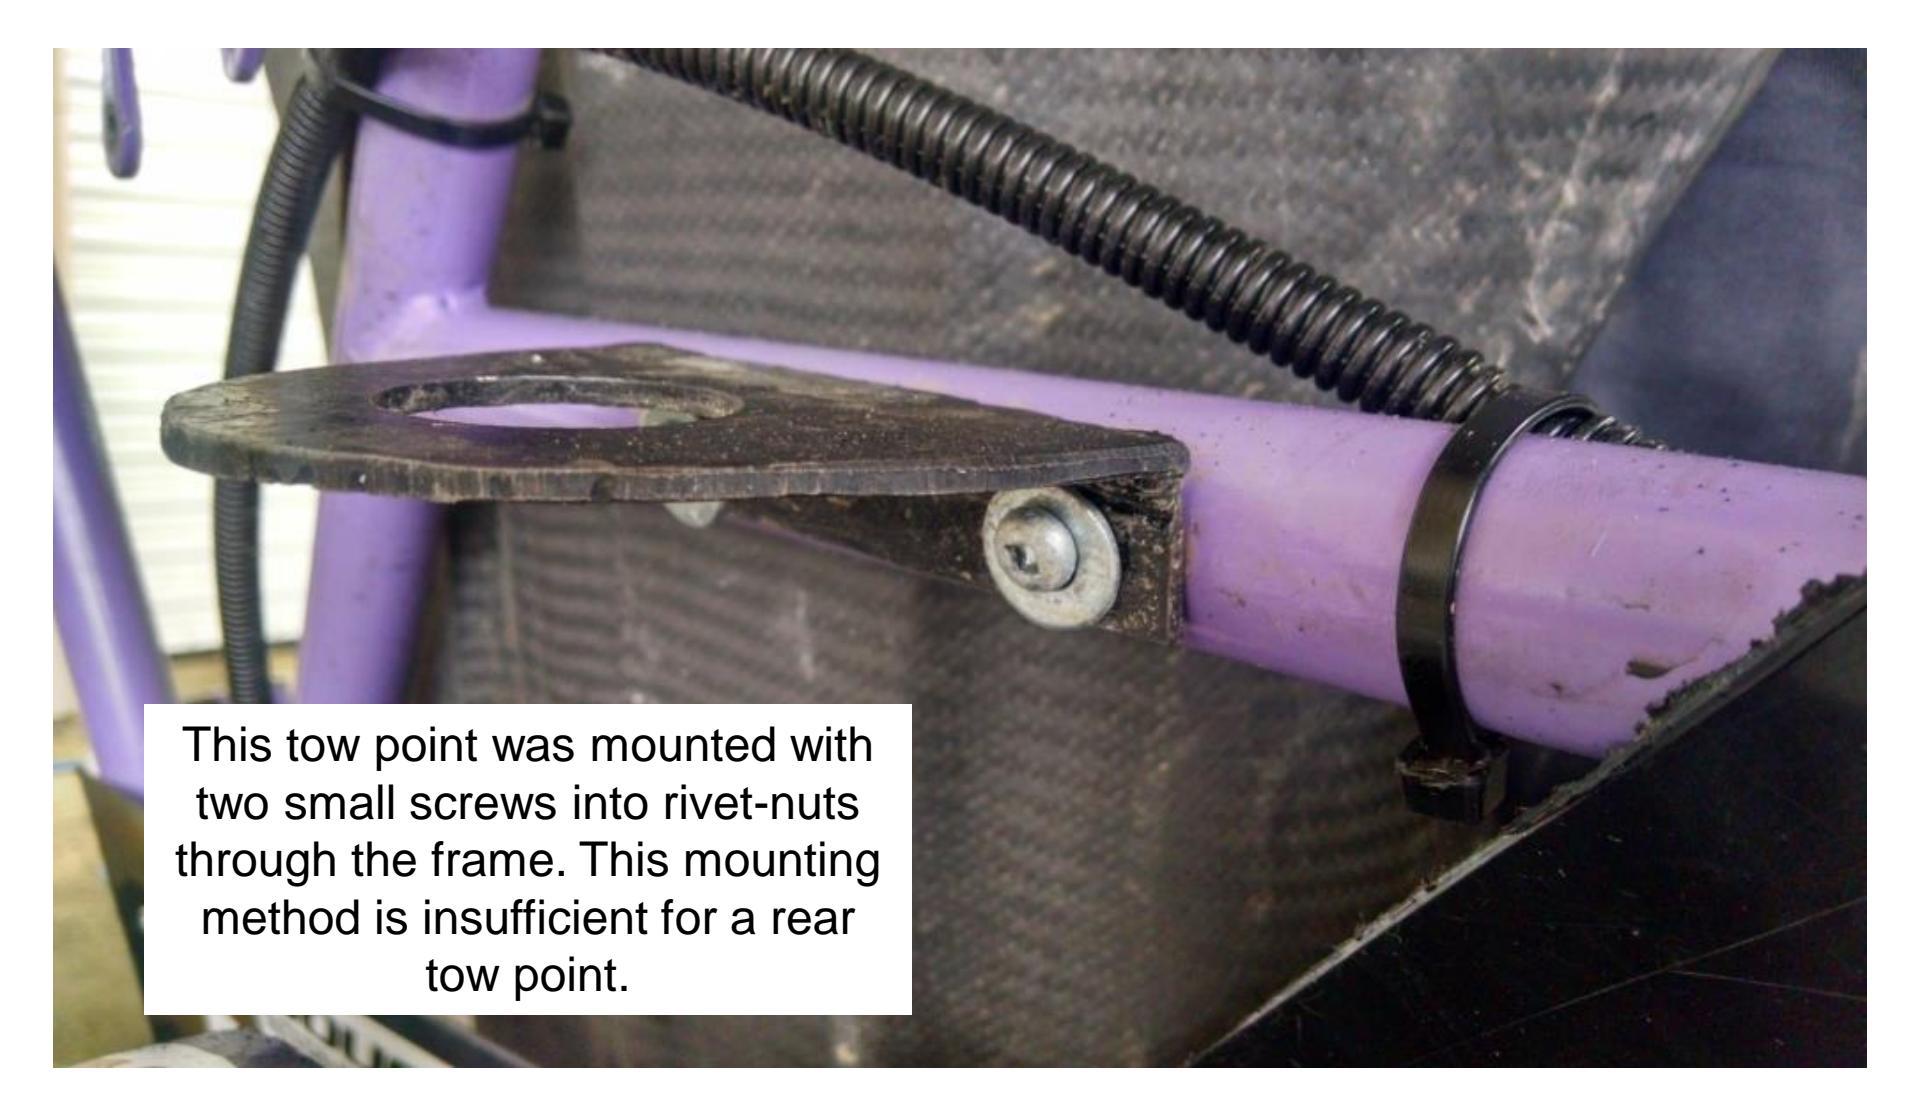
- Many teams did not meet the front tow point requirements. Tech inspection will have a 2" x 8" block that must pass through the front tow point.
- Make sure body panels or numbers do not interfere with the front tow point.
- Make sure the rear tow point is strong enough to serve as a vertical lift point for the vehicle.
