### **Baja SAE Technical Inspection Bulletin**

2015-1

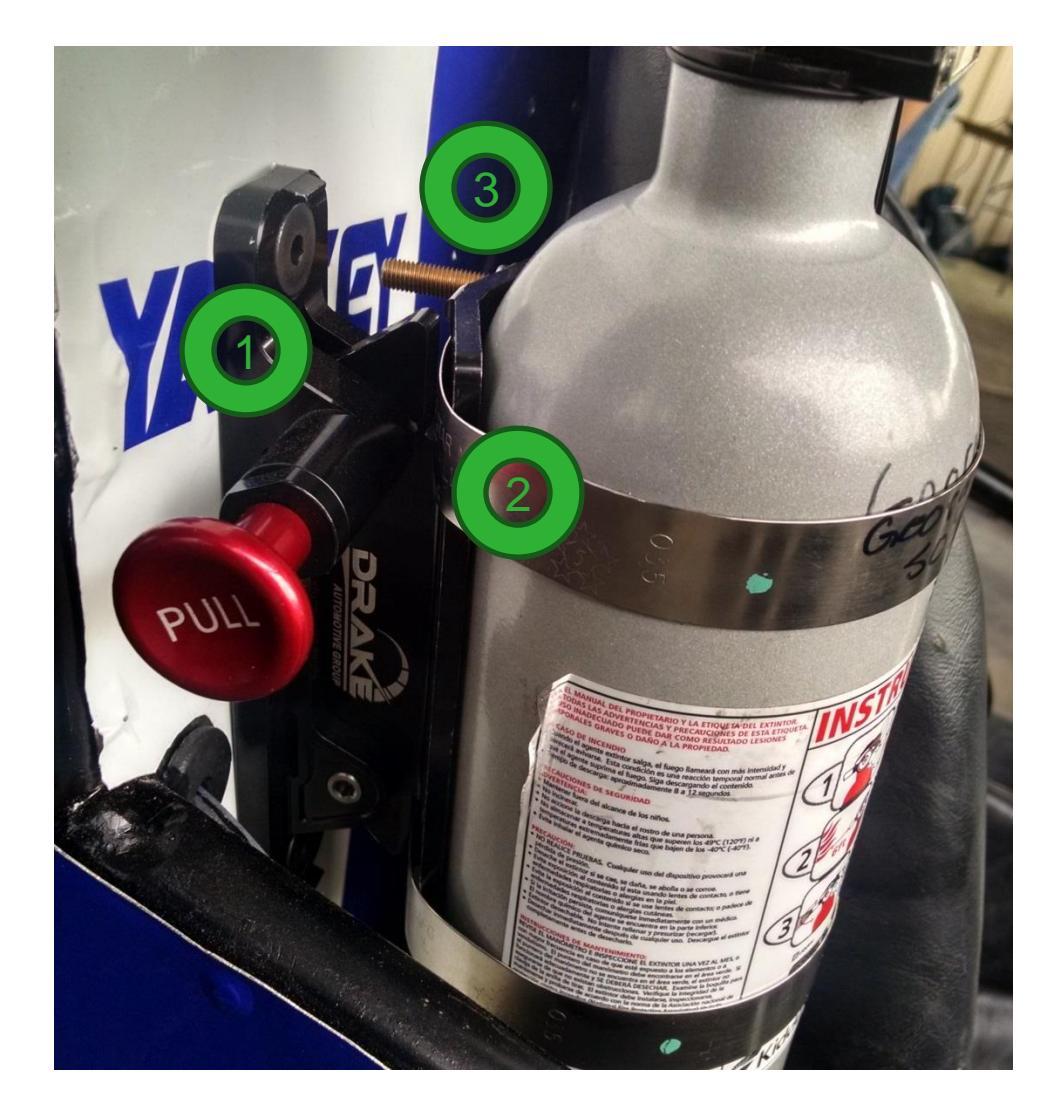
- Appropriate

hardware (Flat head socket head
   cap screw)
- Proper clamp routing through notches
- 3. Clamp hardware positioned away from pull knob.

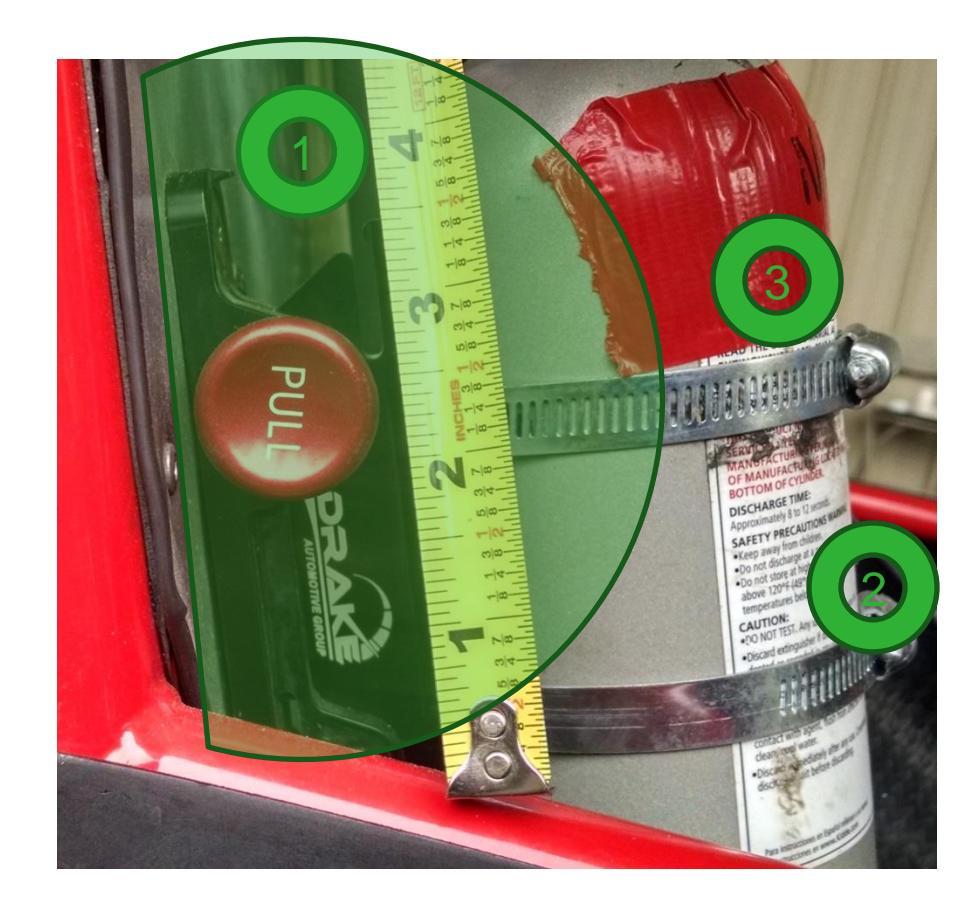
- Appropriate

hardware (Flat head socket head
   cap screw)
- 2. At least 2 inches of radial clearance around knob forward of firewall.
- Clamp hardware positioned away from pull knob.

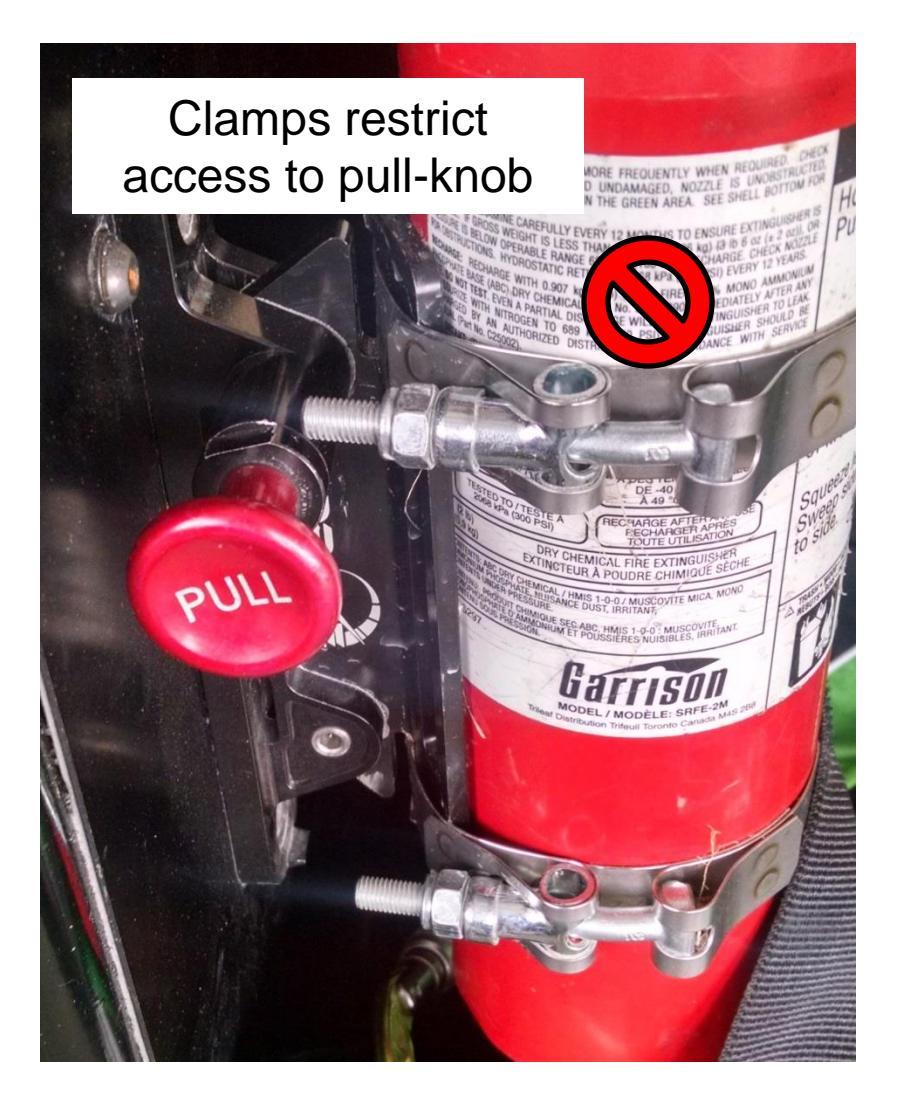
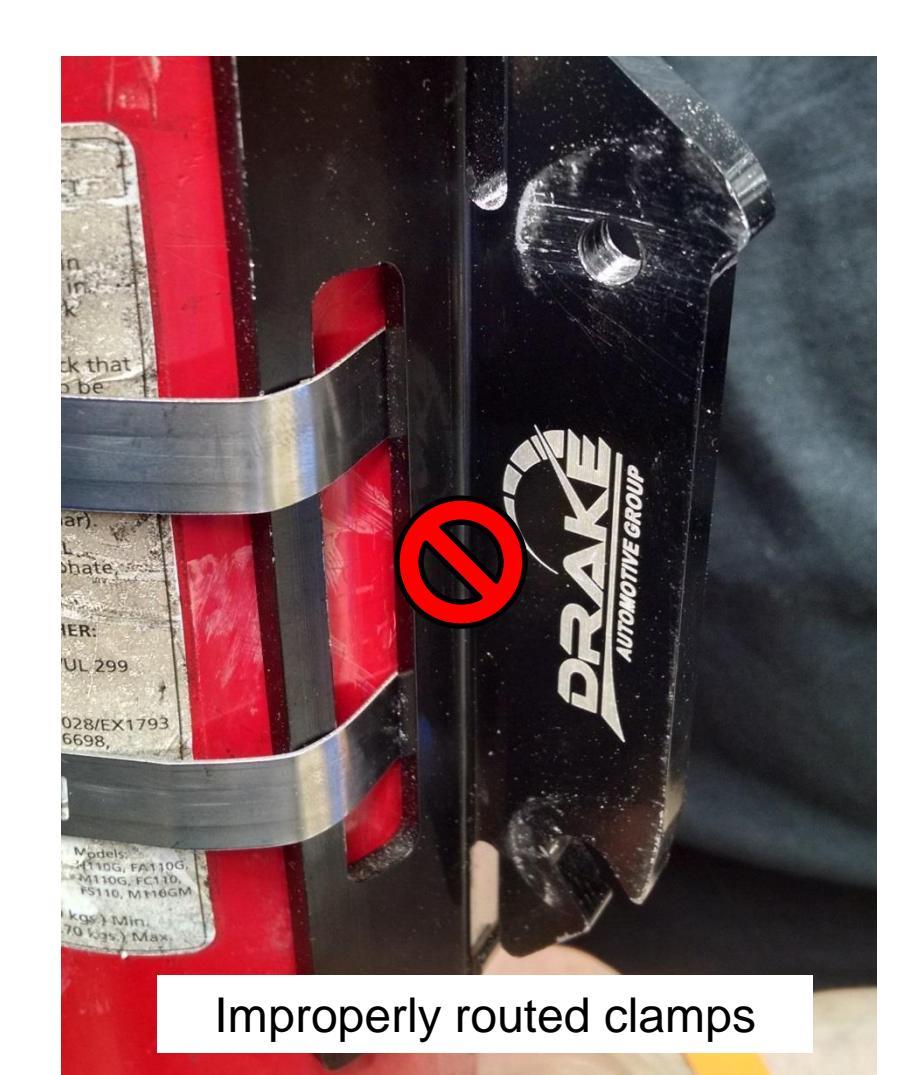
- Improper hardware for mount design.
- Sharp edges near pull knob.
- Insufficient clearance around pullknob.

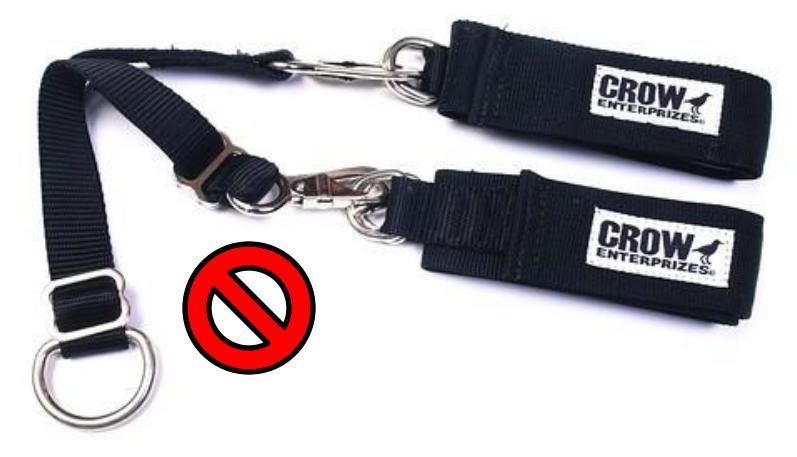
- CHECK YOUR DATES several teams were sent away because their equipment:
  - Did not have a date tag.
  - Was expired.
- Do not remove any SFI tags.
- Check your helmets for the M2010 sticker under the helmet liner.
- Many date tags are not coincident with the SFI tag. The date tag is sewn on in a different location. See photo in rule B10.5.3
- Wrist restraints must be separate items left-to-right. Wrist restraints joined with a common ring in the center are not acceptable.
- Make sure your wrist restraints have plenty of adjustment to keep your arms within the vehicle.
